PERATION

GREENHOUSE

SCIENTIFIC DIRECTOR'S REPORT

ANNEX 3.2 U. S. NAVY STRUCTURES

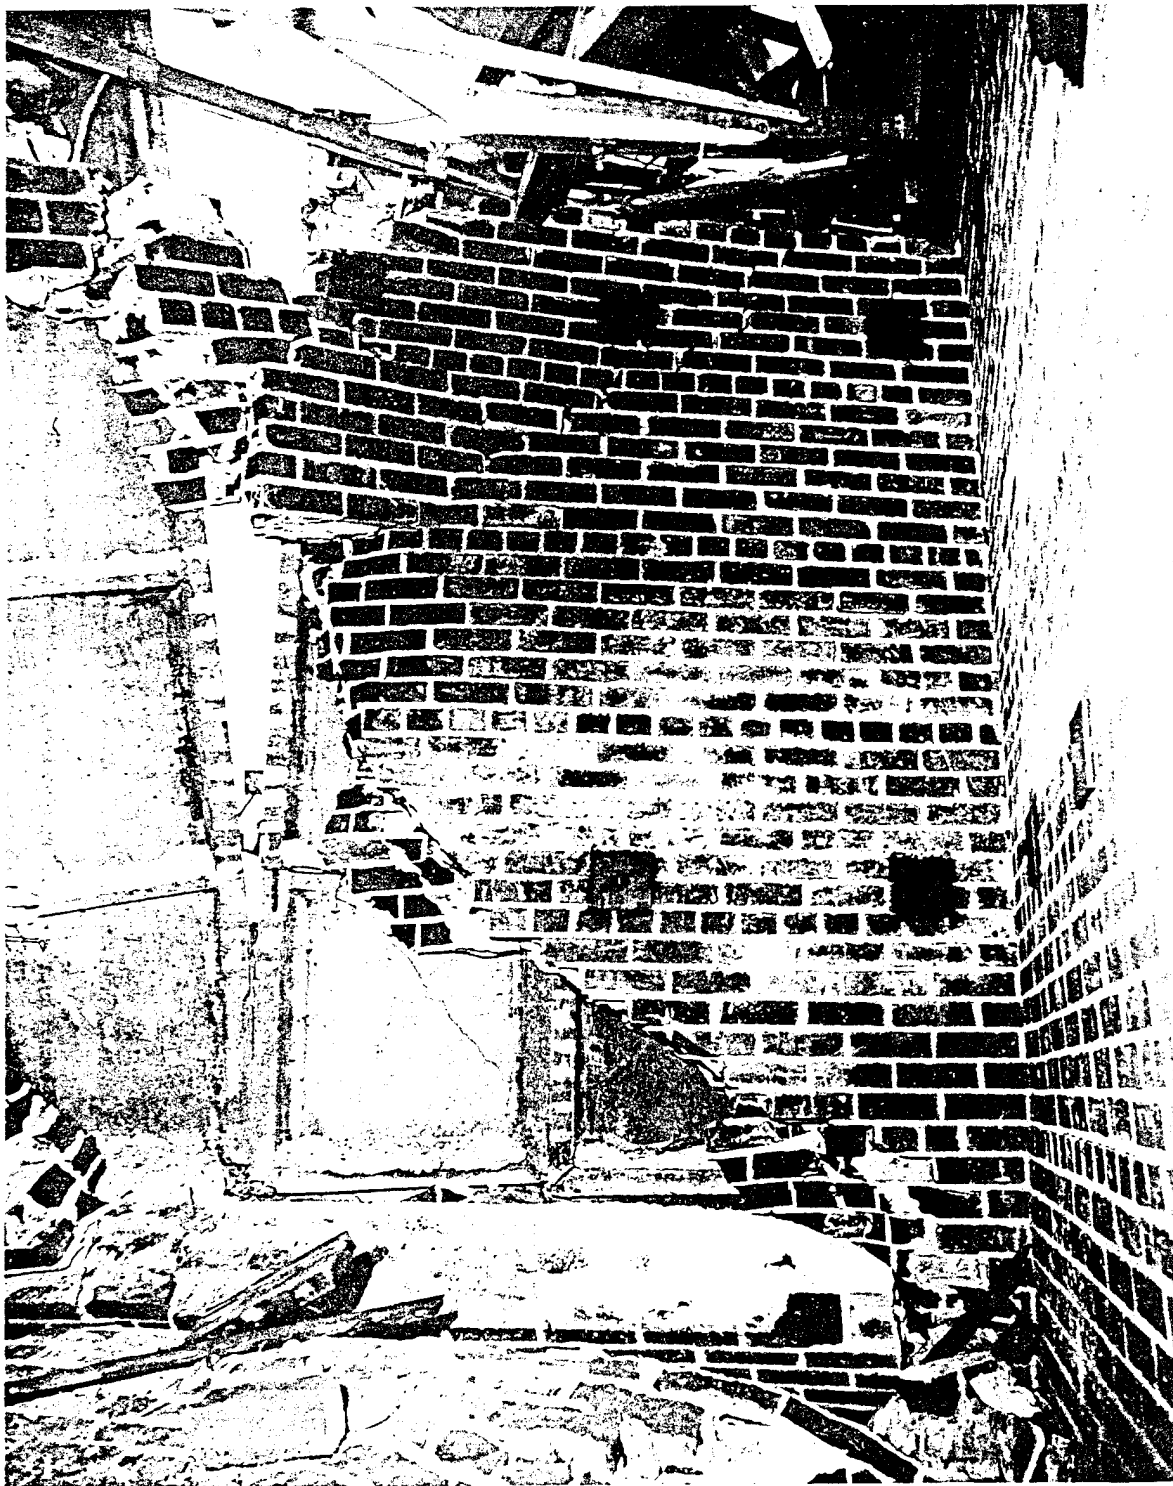
Fig. L.149 Interior View at Left Front Corner, Structure 3.2.2b

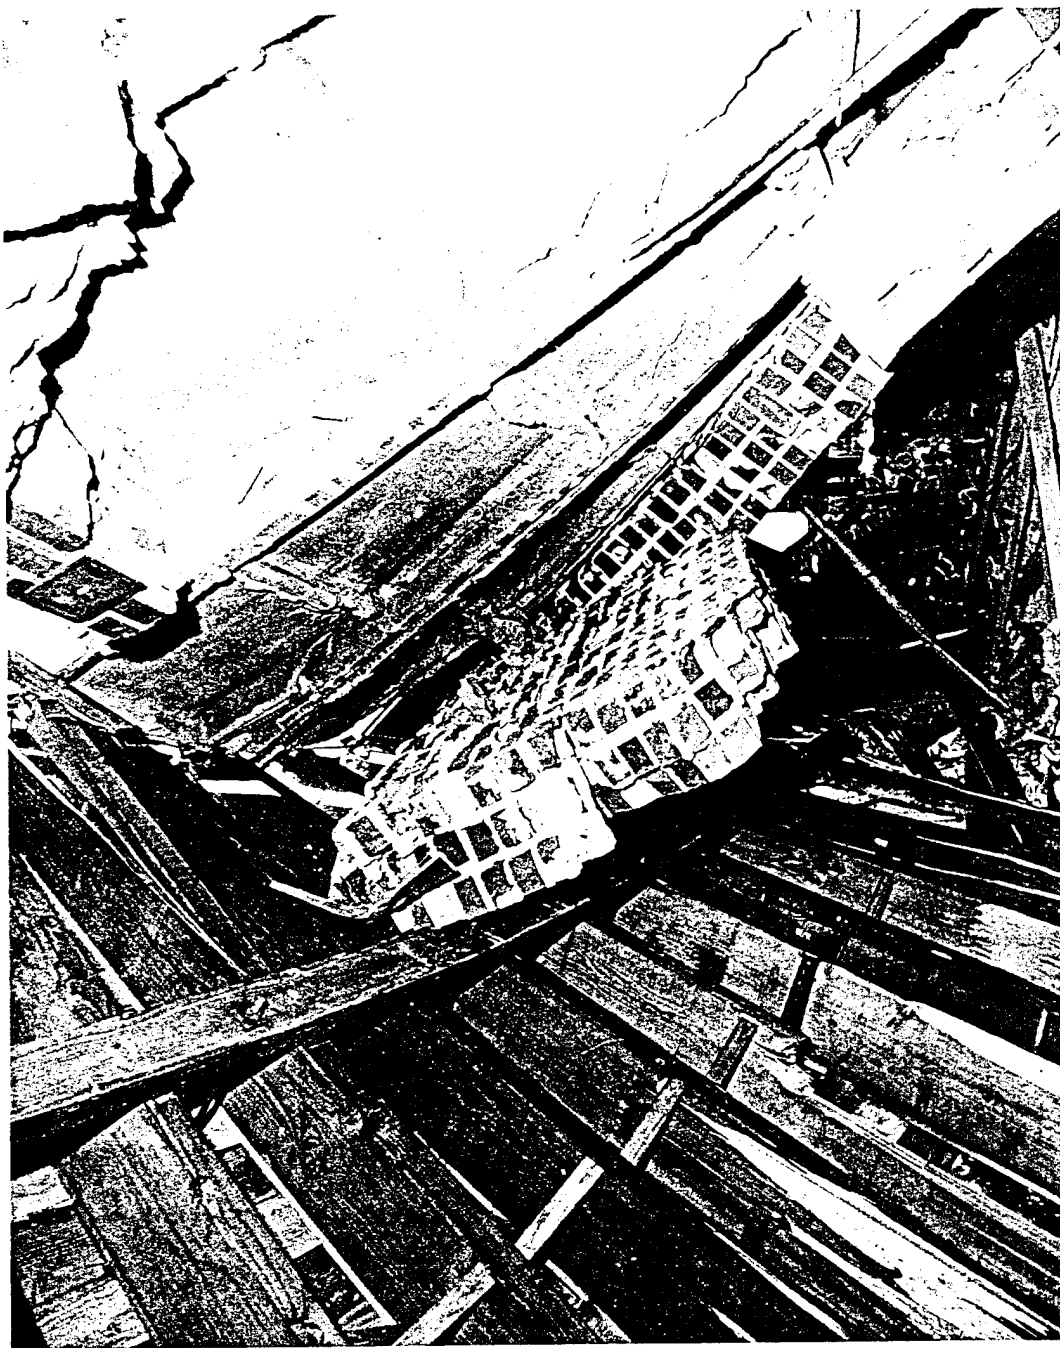
Fig. L.150 Looking toward Center Interior of Building from Left Front Corner, Structure 3.2.2b. Note hanging brick.

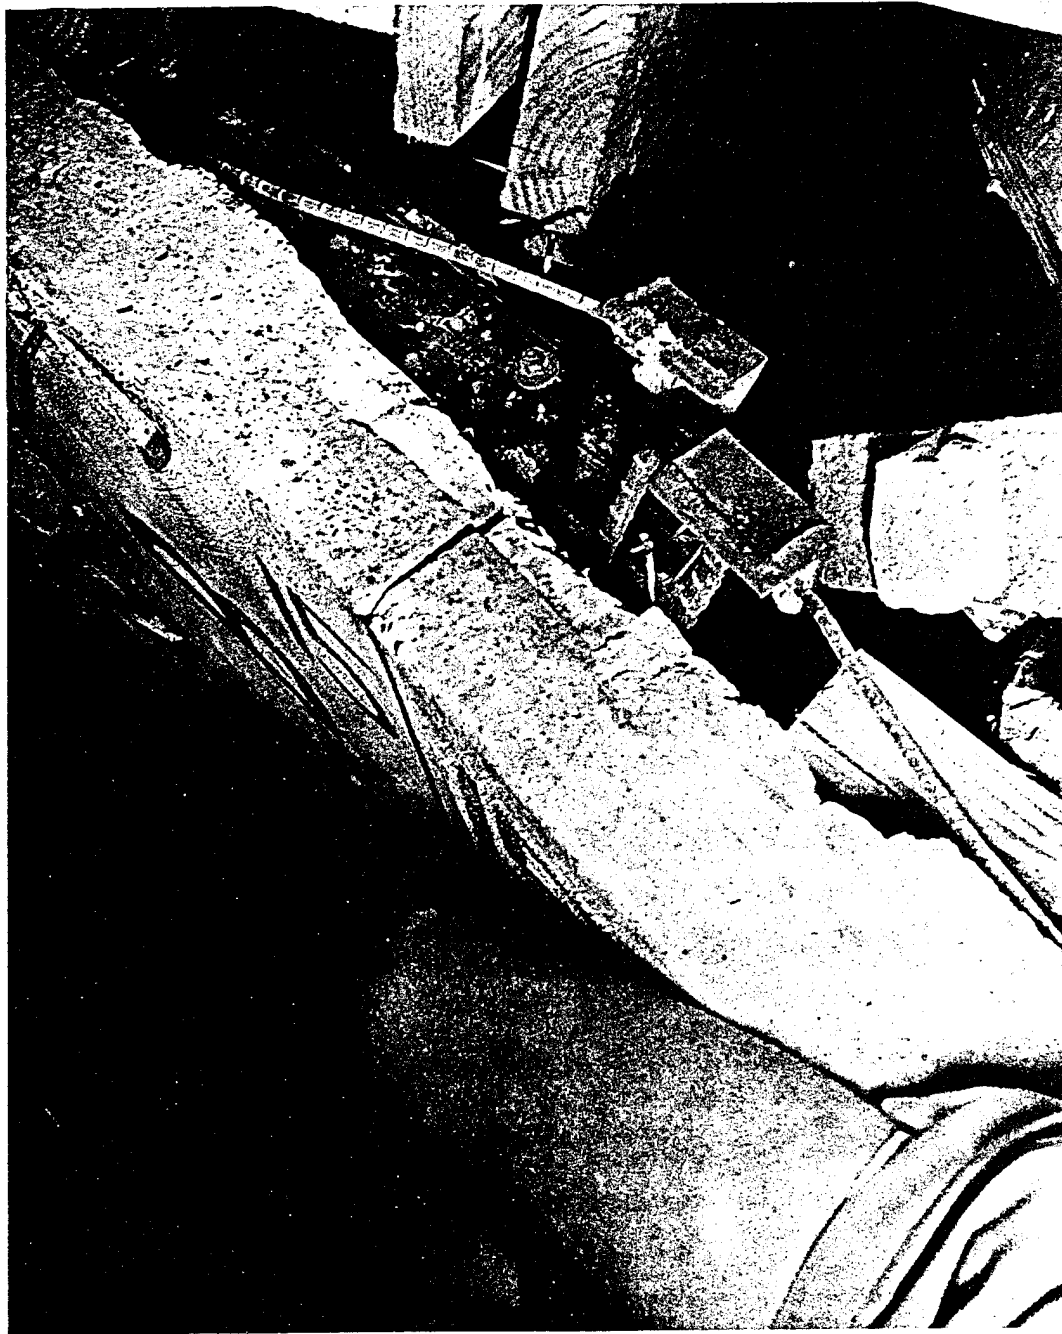
Fig. L.151 Weld Failure atop Front-wall Panel Where Splice Plate Tore Loose, Structure 3.2.2b

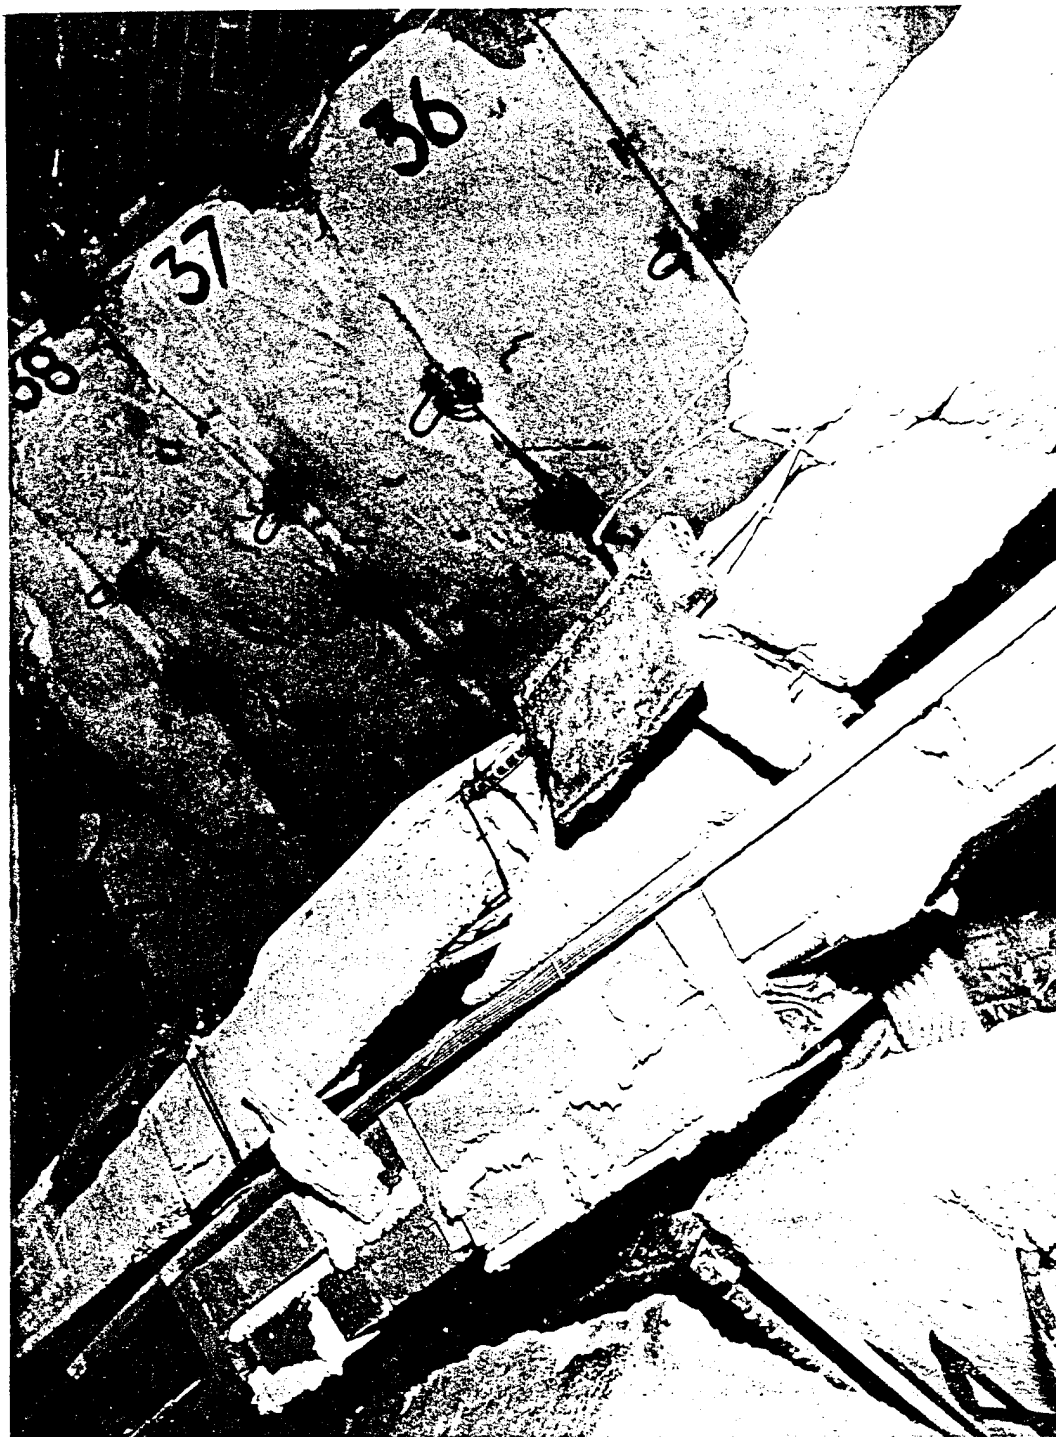
Fig. L.152 Weld Failure at Splice Plate Which Has Torn Loose from Angle atop Front-wall Panel, Structure 3.2.2b

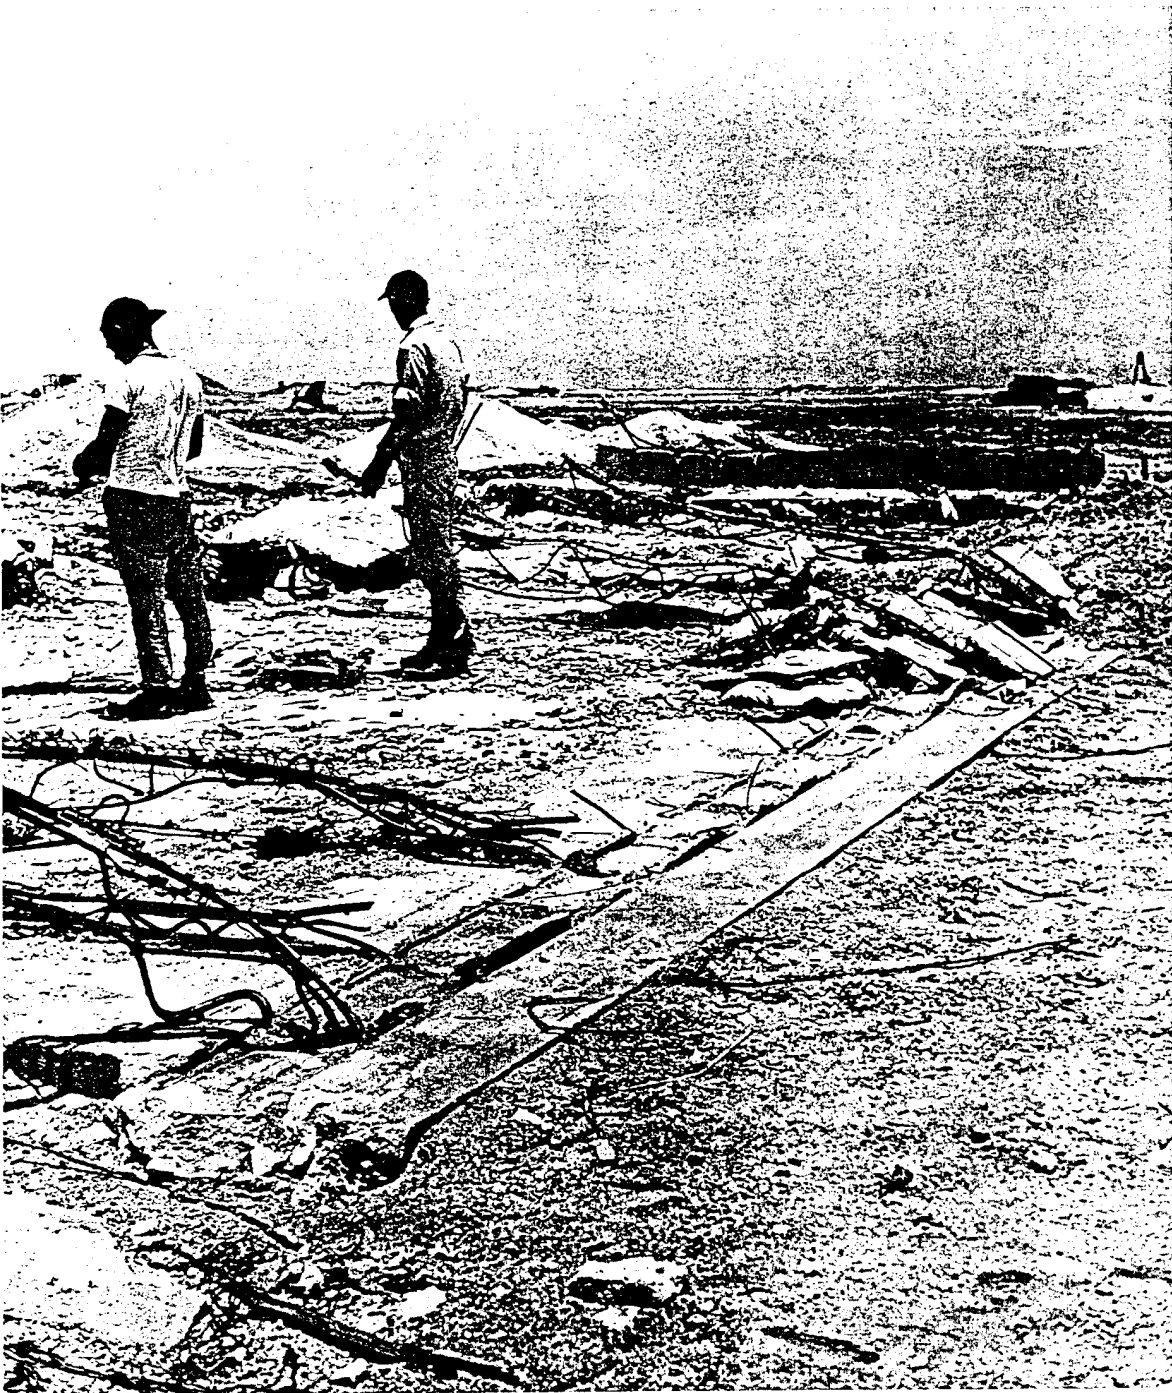
Fig. L.156 View along Front Edge of Foundation, Structure 3.2.3a. Isolated trusses are only remnants of front wall.
Note the "S" curvature of these trusses.

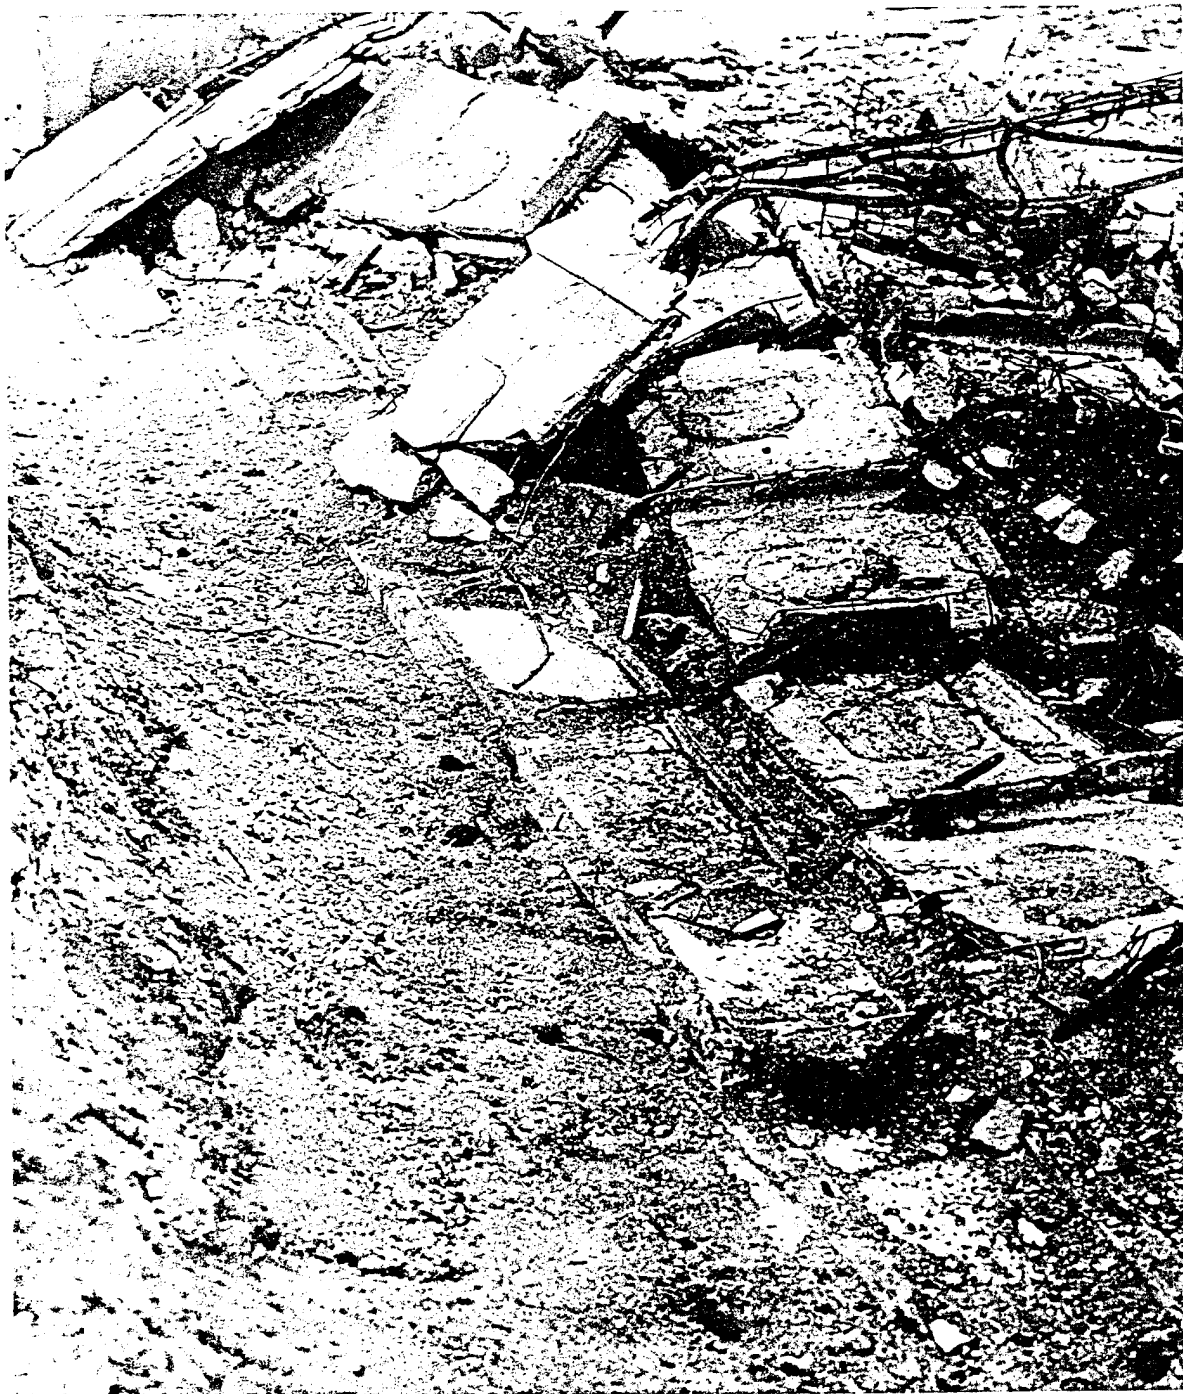
Fig. L.160 Close-up View of Right End of Front Foundation Line, Structure 3.2.3a

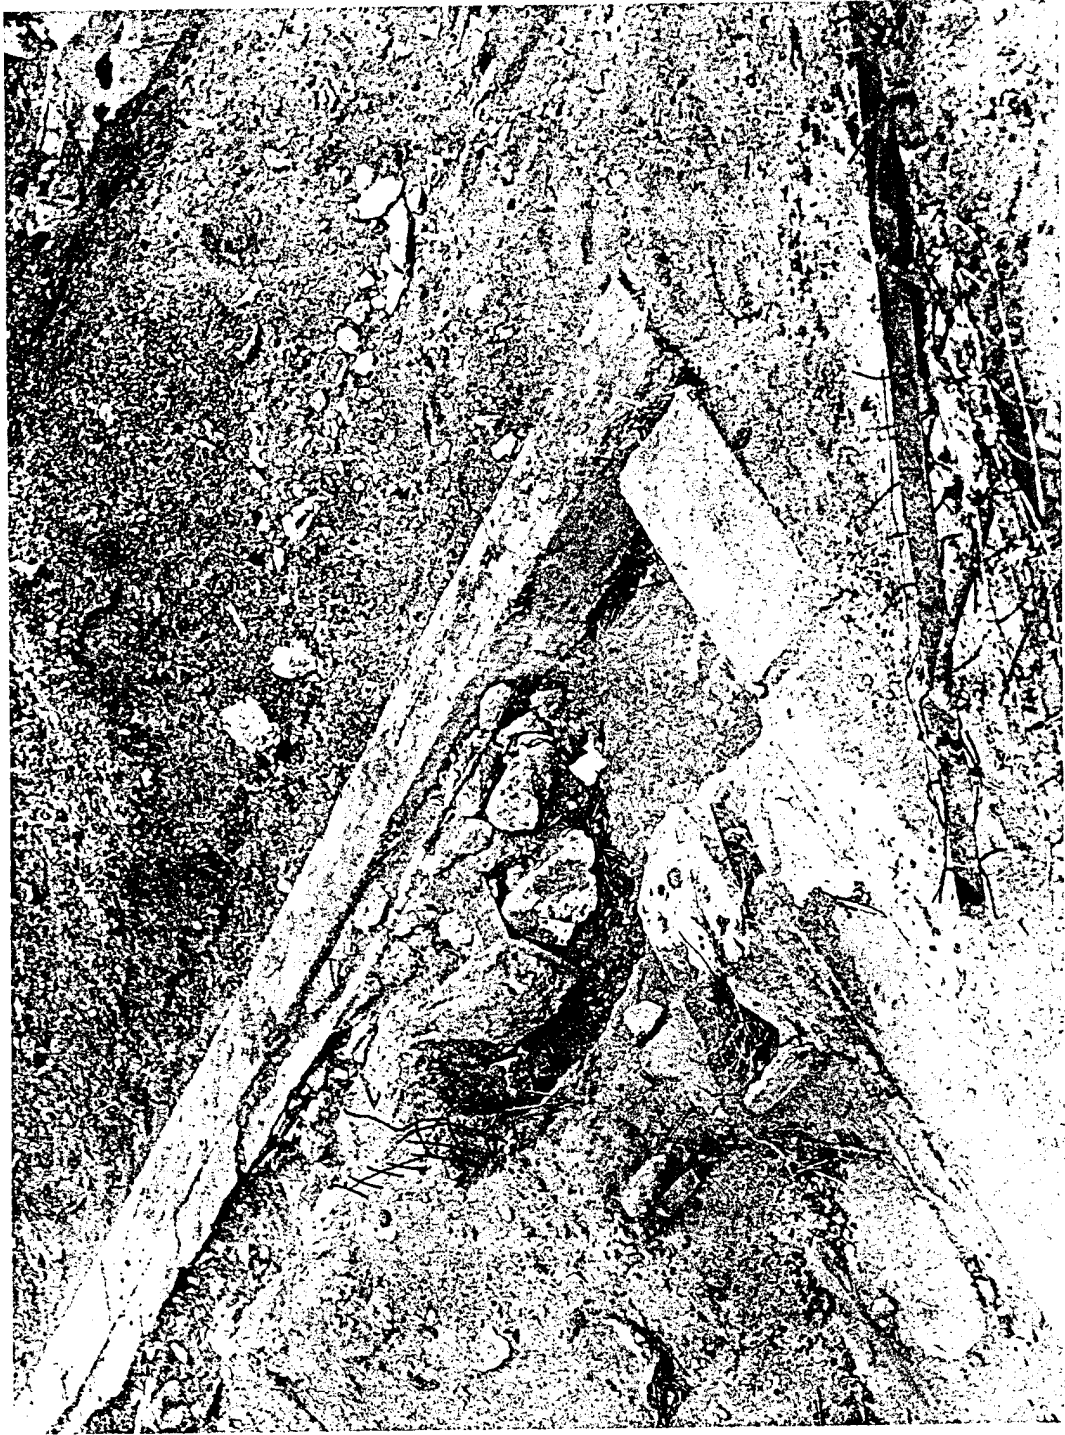
Fig. L.161 Front Right Corner of Foundation Cracked Loose When Right End Wall Was Forced Outward, Structure 3.2.3a

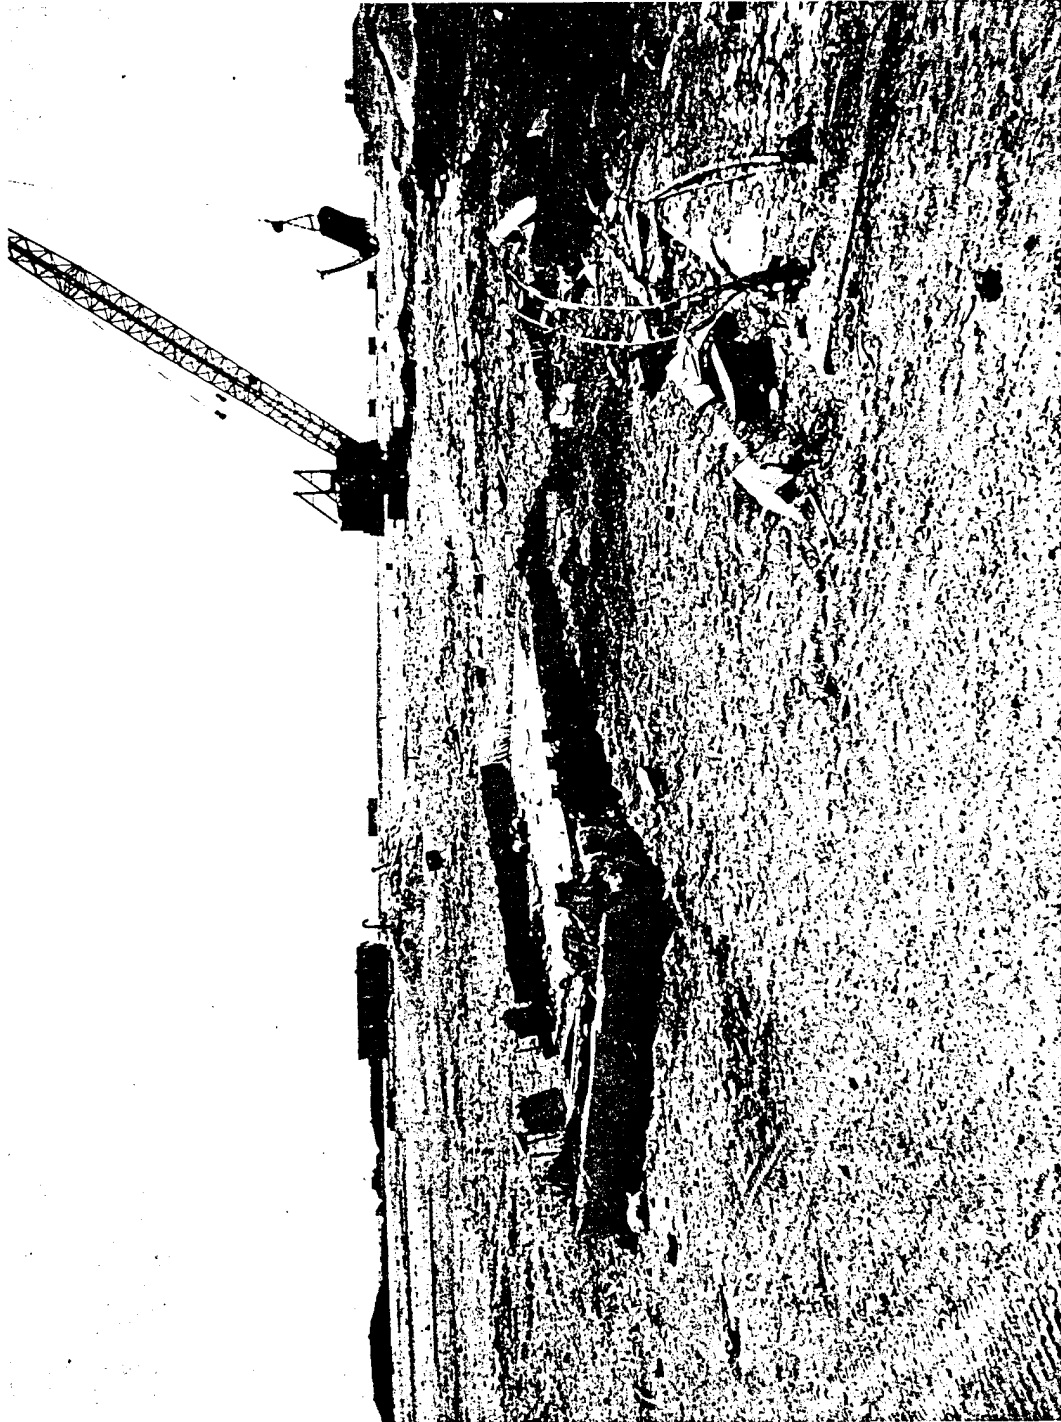
Fig. L.163 General View of Left End Wall, Displaced about 15 ft to Left of Foundation, Structure 3.2.3a. Left edge of foundation can be seen in right side of photograph.

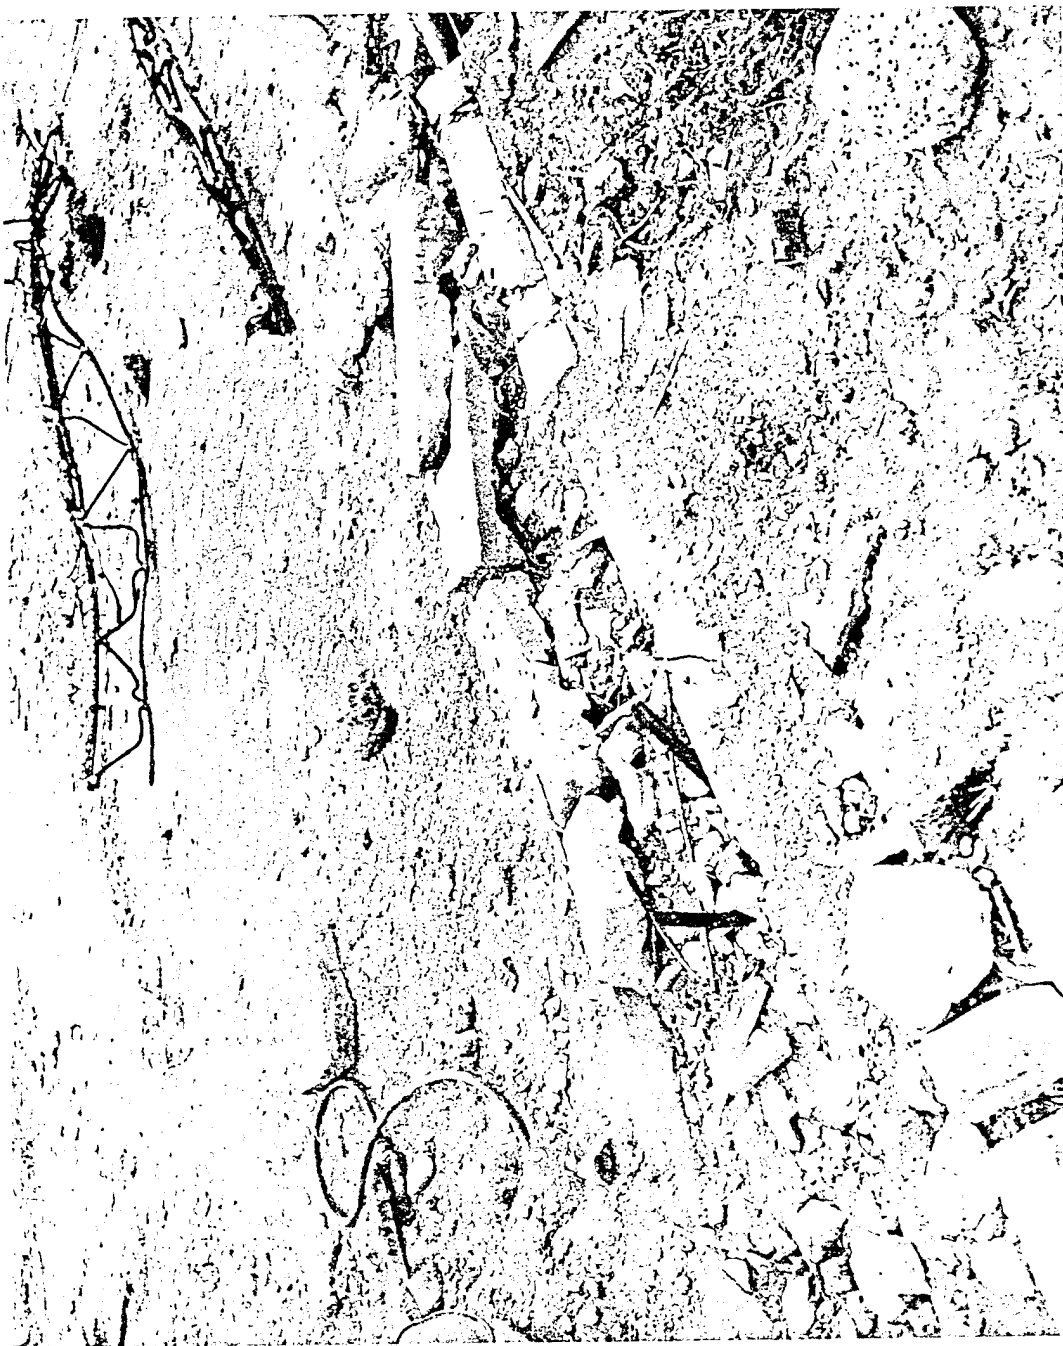
Fig. L.164 Close-up View of Foundation Where Left End Wall Had Been Anchored, Structure 3.2.3a

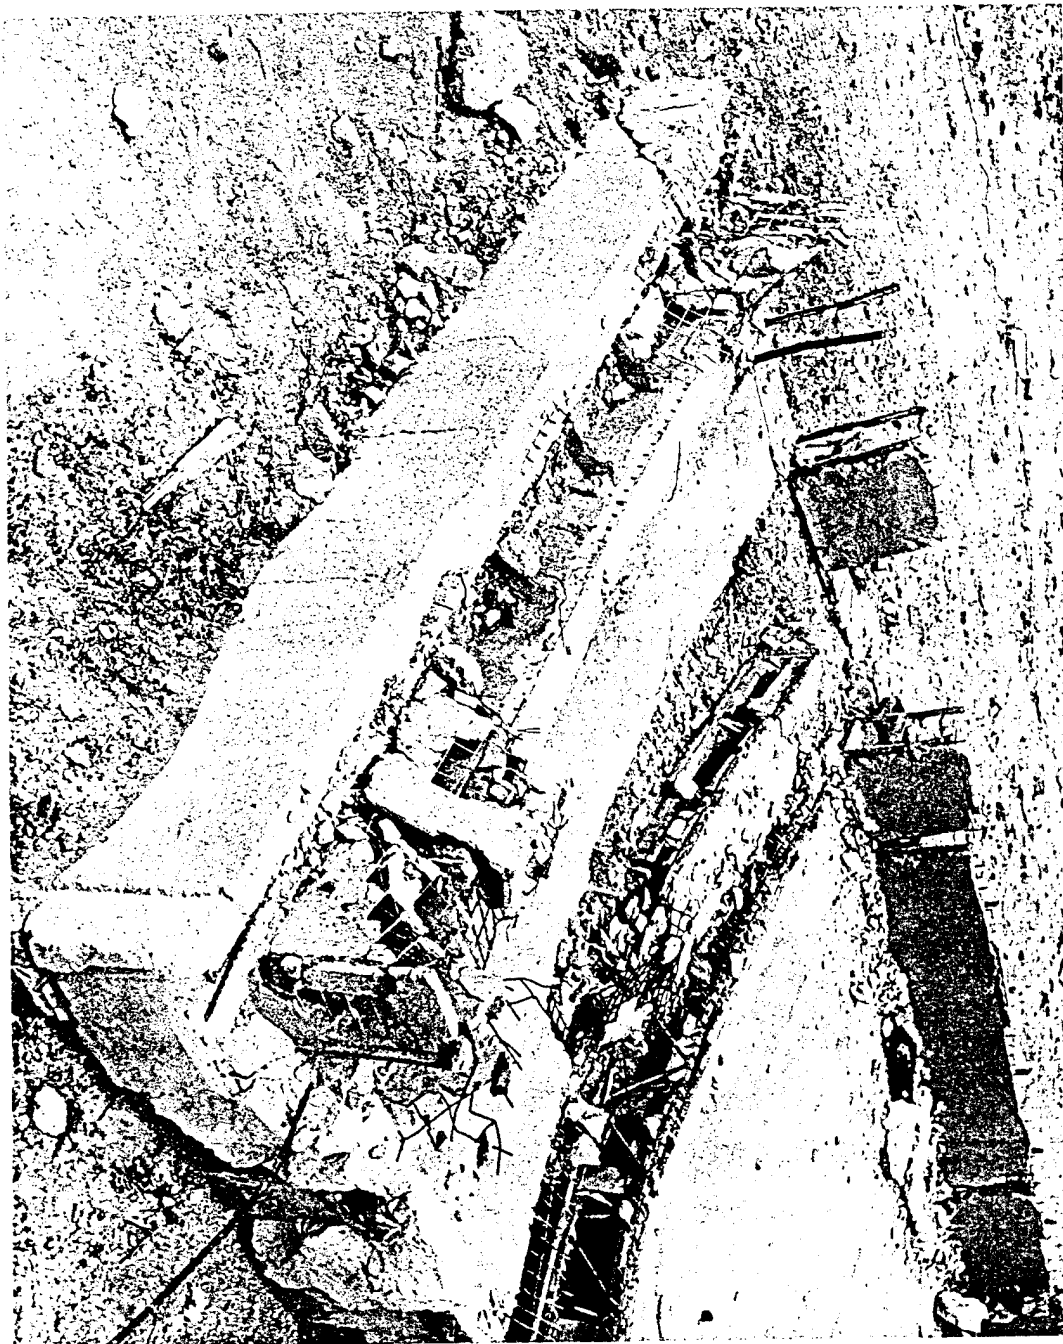
Fig. L.166 Plane of Separation of Plaster Corner from Front Wall (Foreground), Structure 3.2.3a. Note how cells were severed.

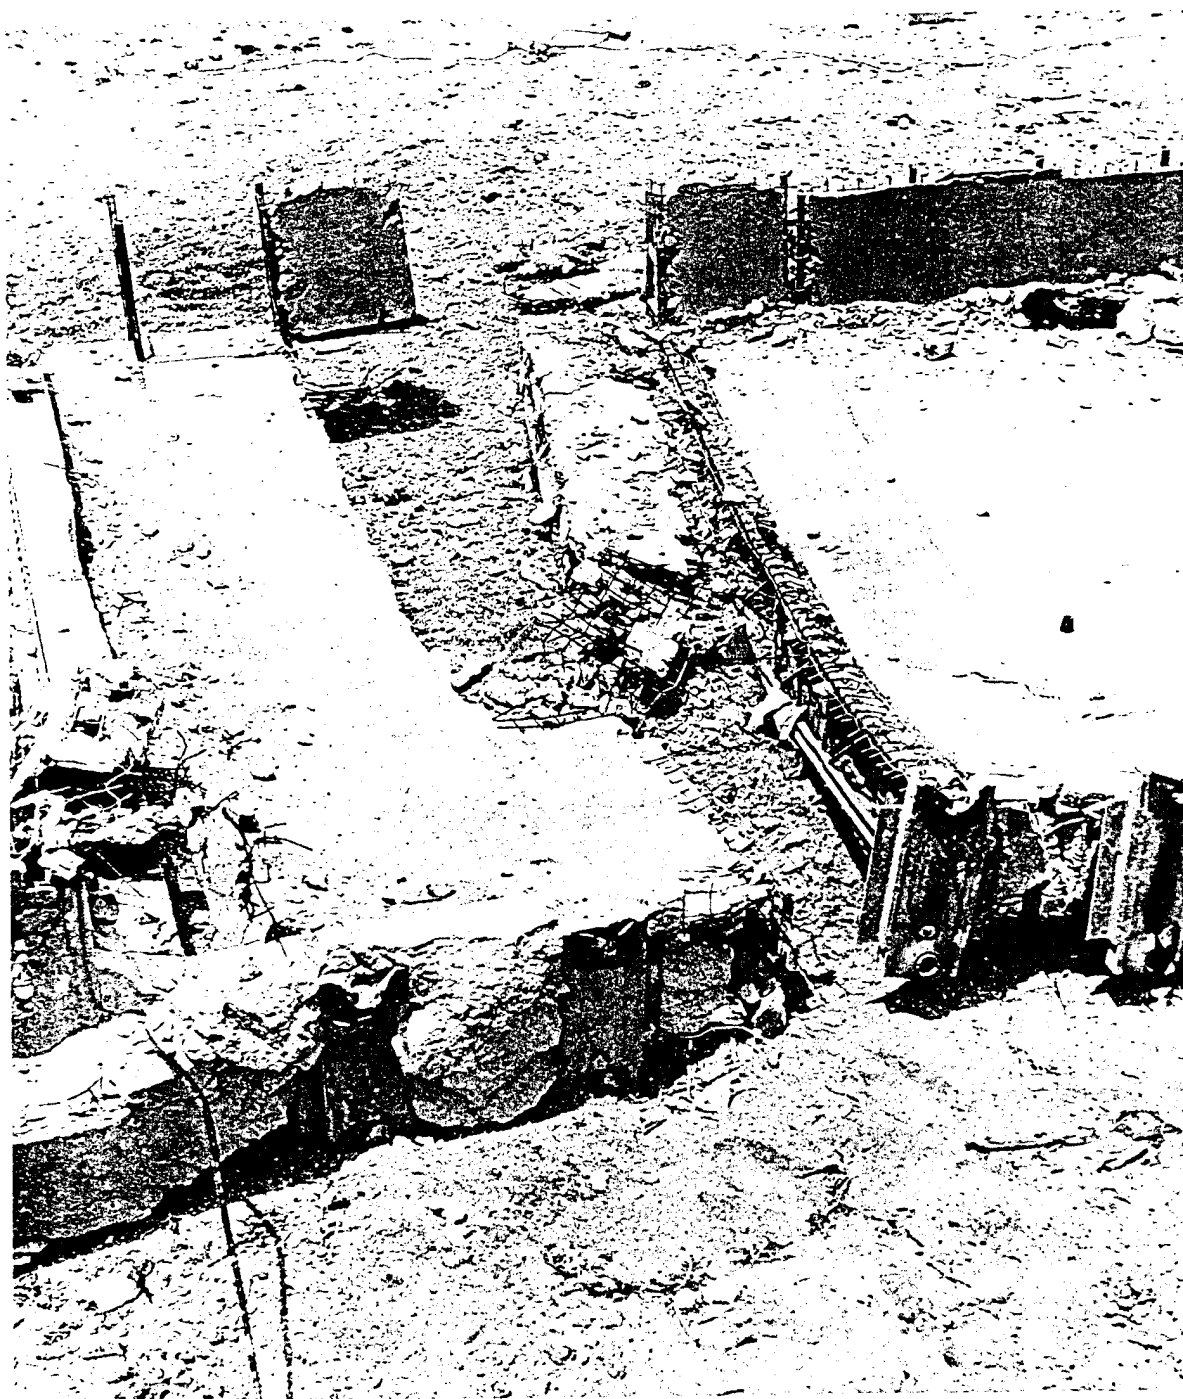
Fig. L.167 Split along Joint Line in Left End Wall, Structure 3.2.3a. Note how steel channels at base of wall pulled out over the anchor-bolt nuts.

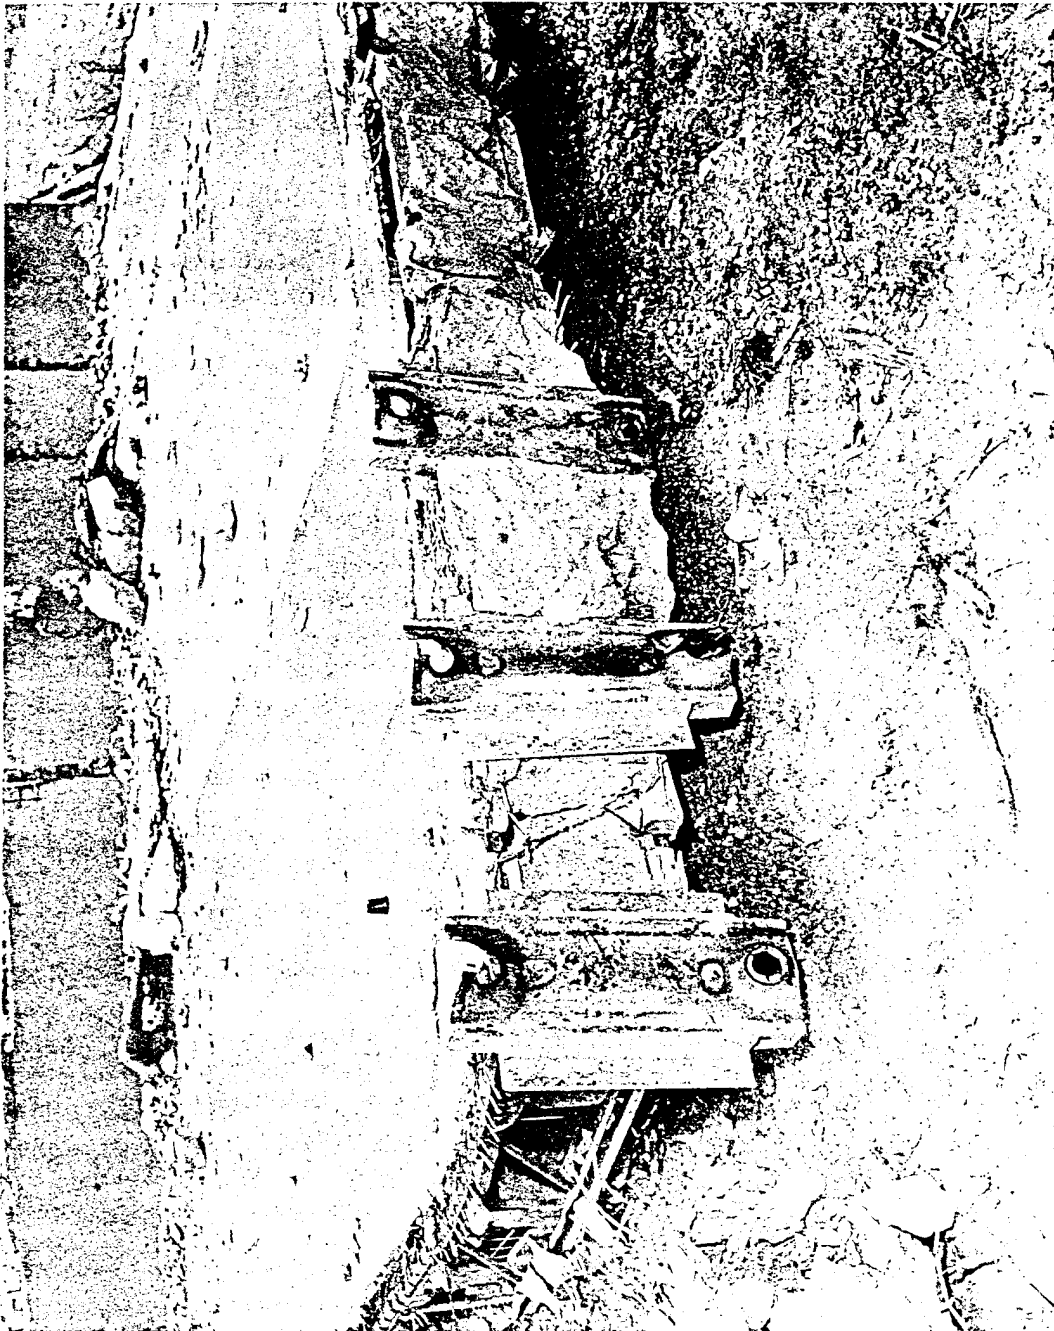
Fig. L.168 Detail View of Base of Left End Wall, Structure 3.2.3a. Note various types of failure at base connection: Channel at right of photo pulled over anchor-bolt nuts, channel in center ruptured, and truss chords in right of photograph pulled loose from channels, which remained anchored to foundation.

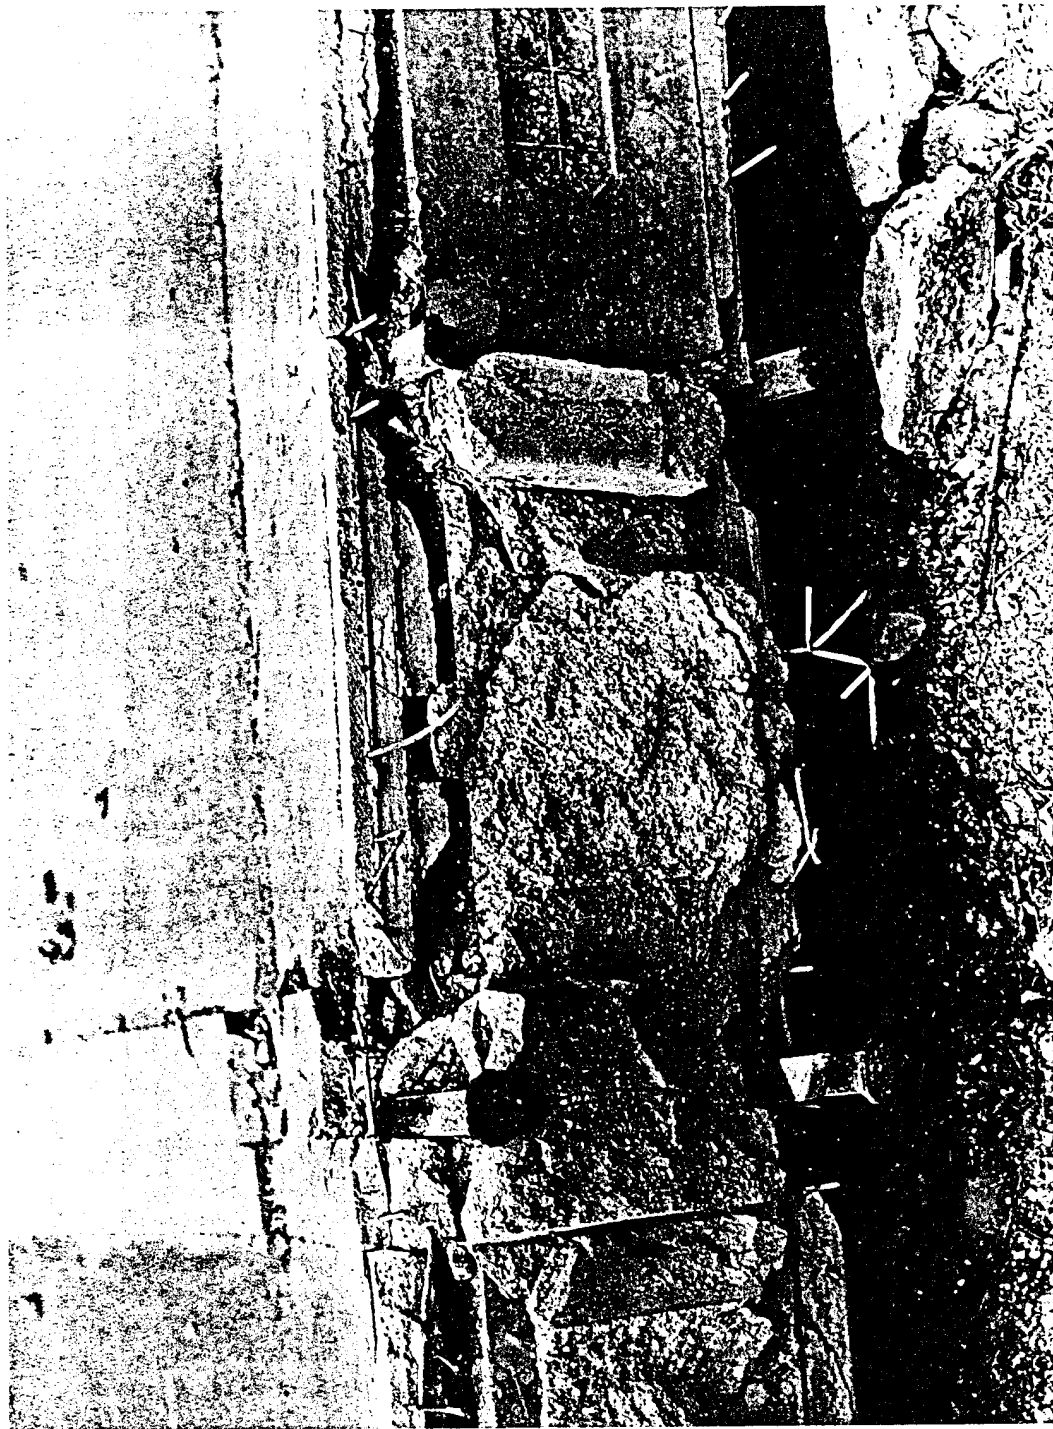
Fig. L.169 Close-up View of Truss Chords Shown in Preceding Photograph, Structure 3.2.3a. Note how parent metal of channel sheared out in left truss and how weld failed in right truss.

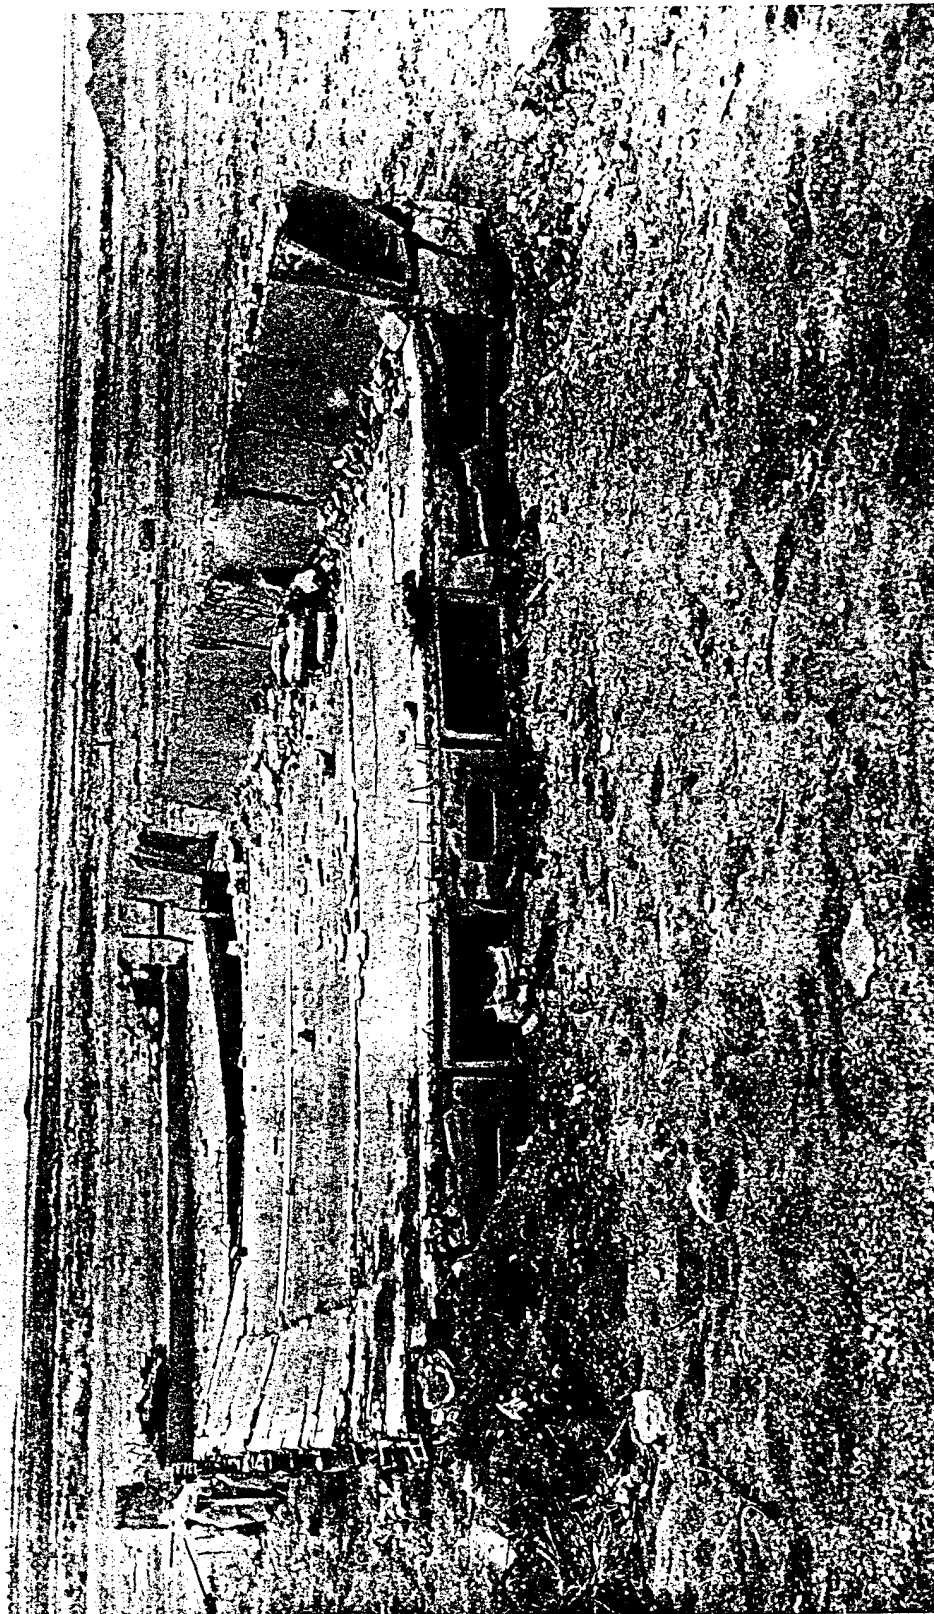
Fig. L.170 Rear Edge of Left End Wall, Structure 3.2.3a. Note curvature of wall panels. One row of roof cells remained attached to end wall.

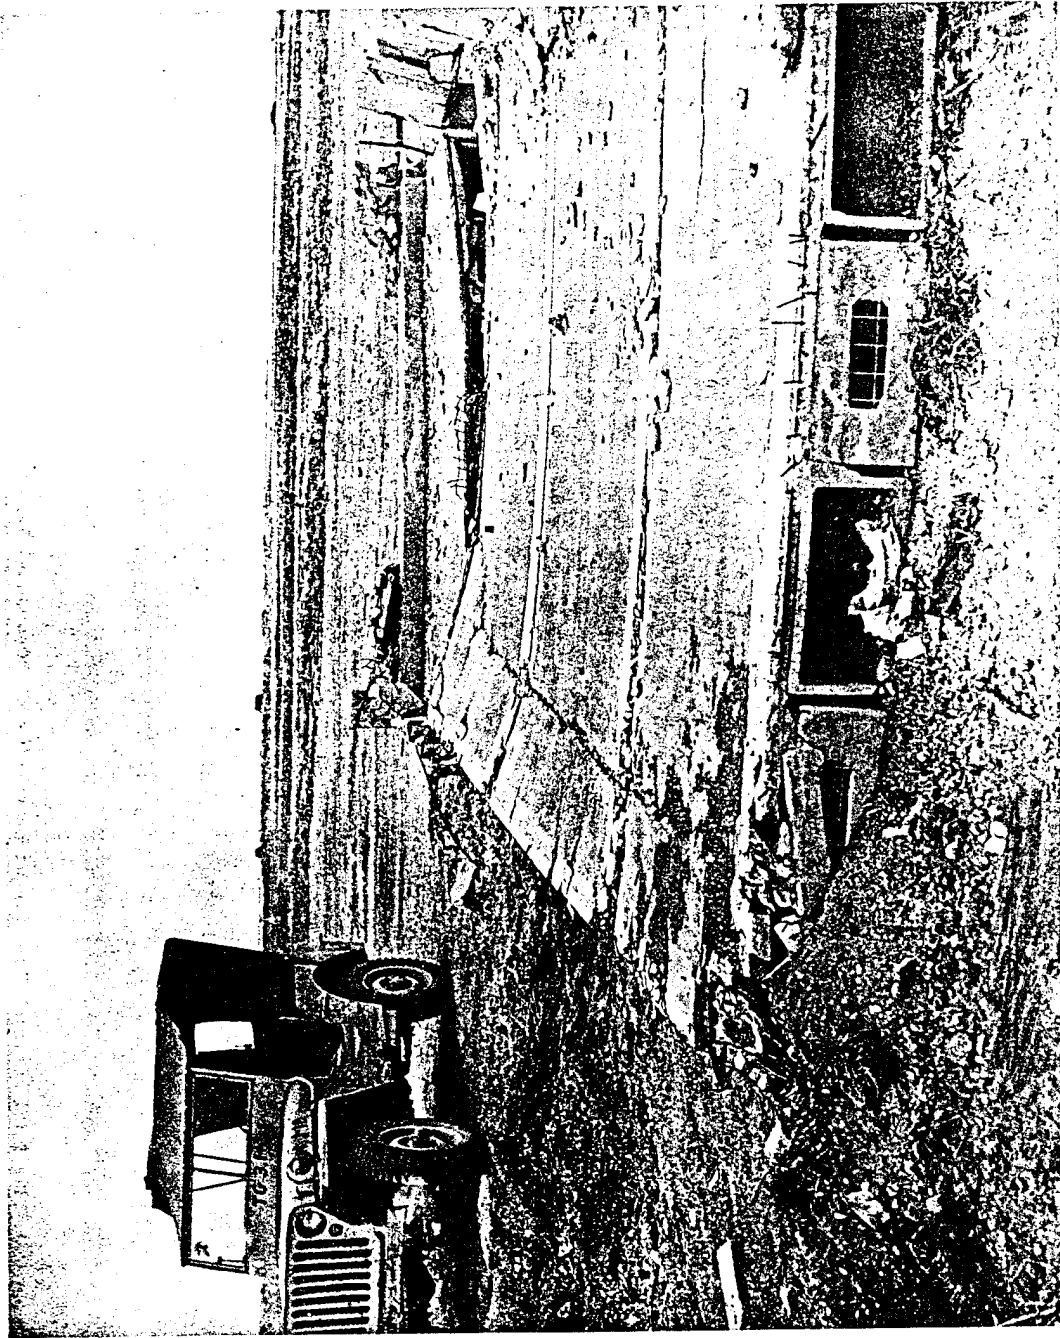
Fig. L.171 Detail View of Rear Edge of Left End Wall, Structure 3.2.3a. Note crack about 18 in. above base of wall.
